Close Out Documents

AP-49 – 2331 E 46th Ave.

Structural Demolition

Structure Survey Assessment Report AP-49

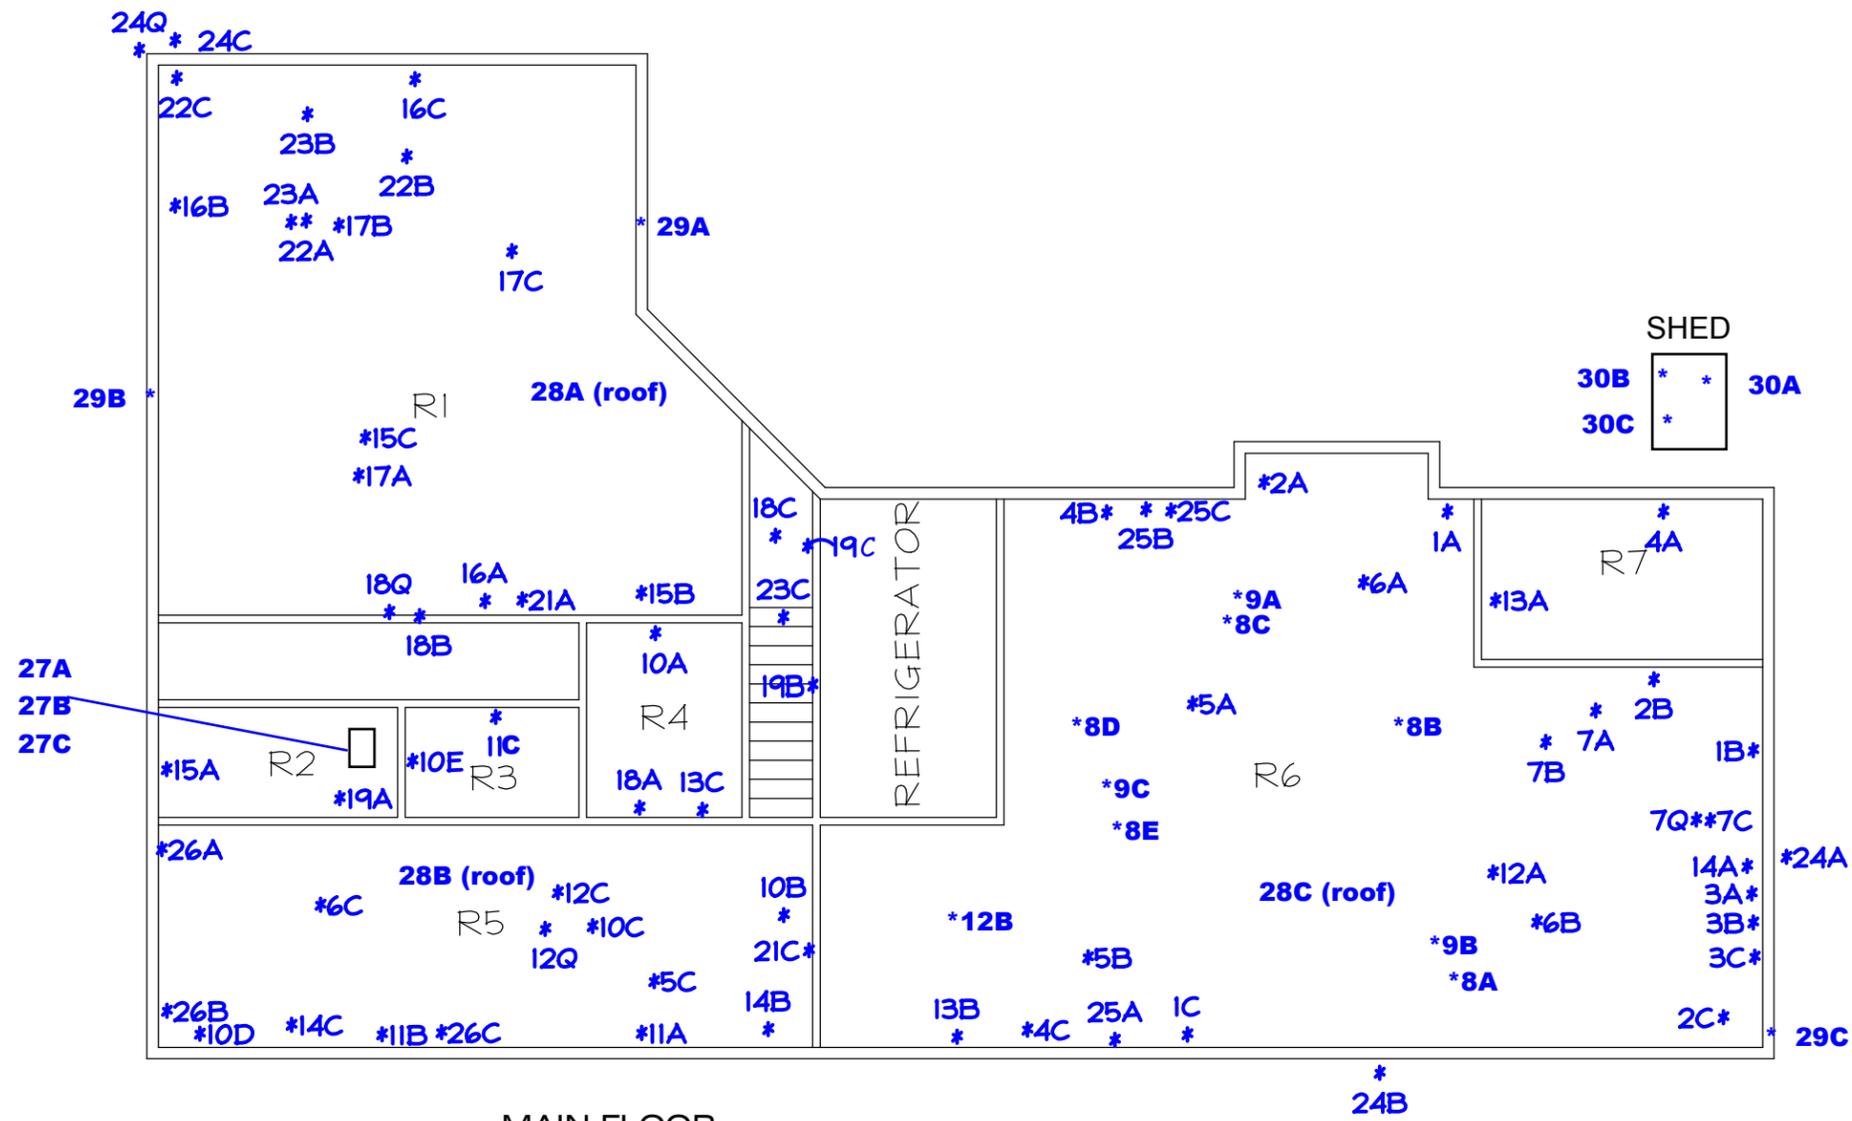
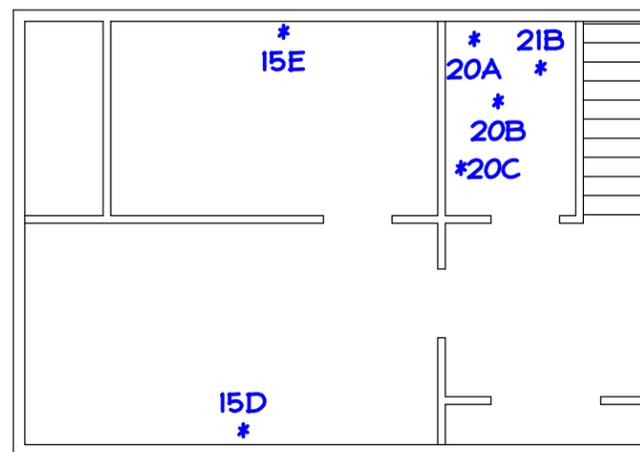
FIGURE 2 - Asbestos Bulk Sample Locations
 CENTRAL 70 - Structure Survey Assessment Map
 AP-49
 2331 E. 46th Ave., Denver, CO
 May 17, 2018
 APEC #: 18-3066

MAIN FLOOR

BASEMENT

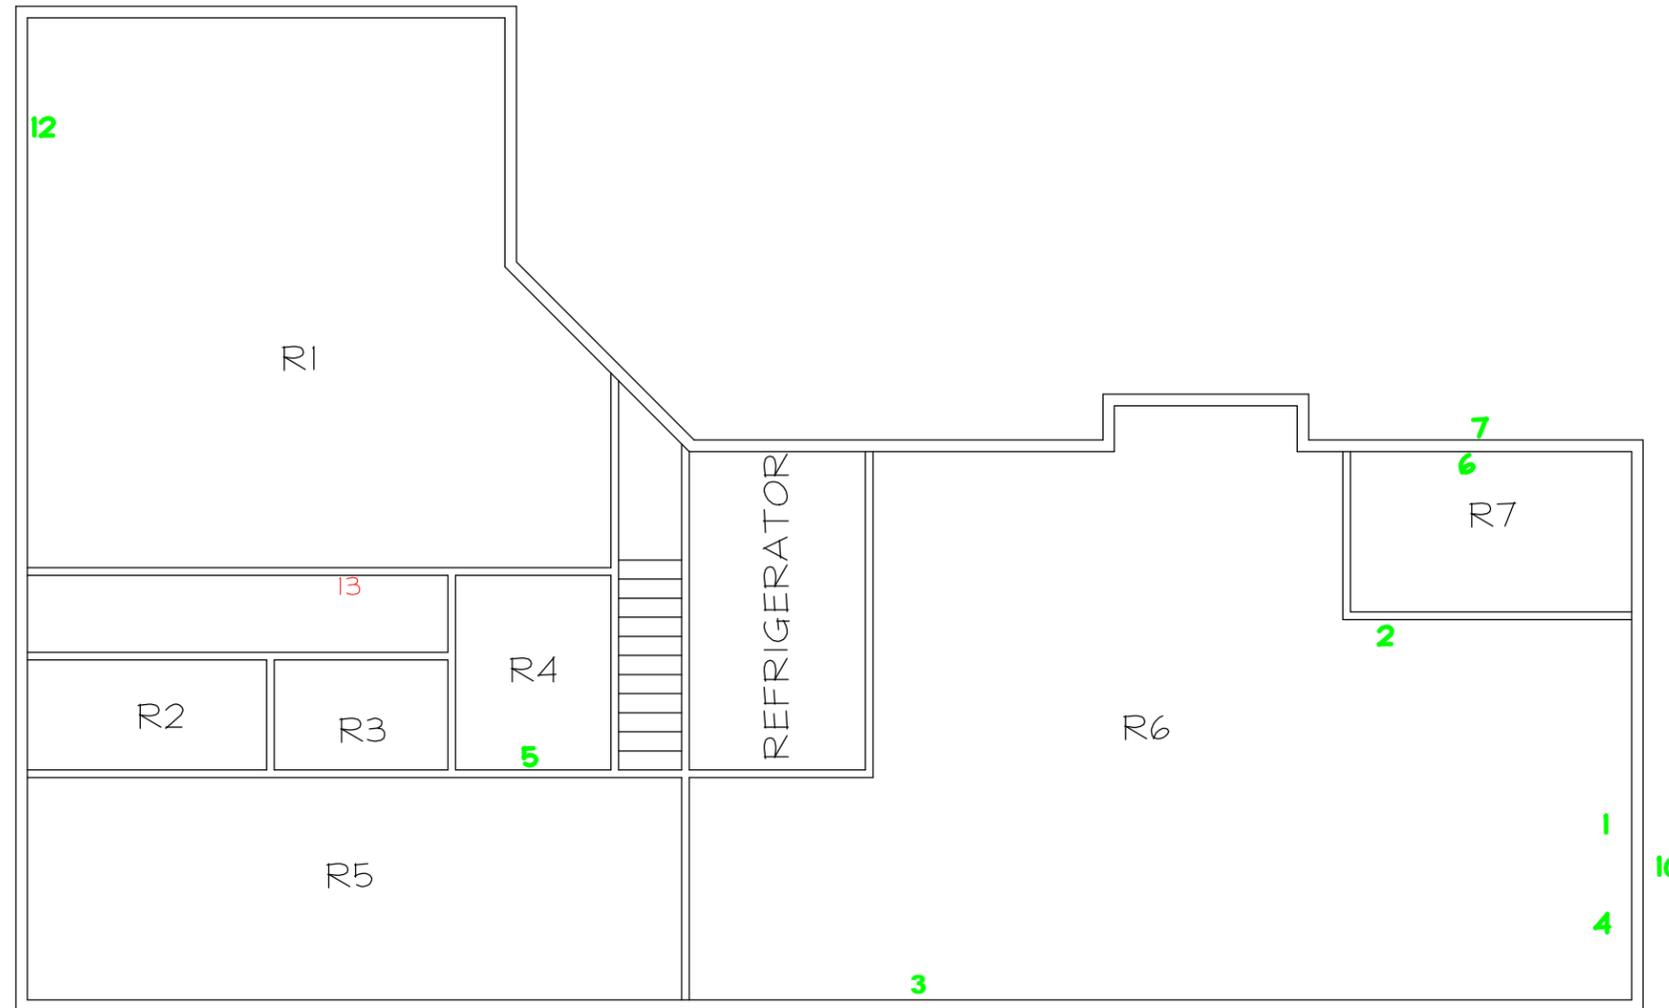
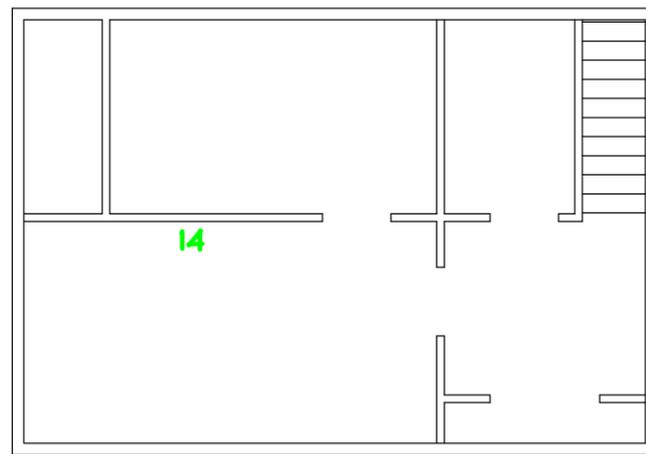
FIGURE 3 - Lead Based Paint Sample Location
 CENTRAL 70 - Structure Survey Assessment Map
 AP-49
 2331 E. 46th Ave., Denver, CO
 May 17, 2018
 APEC #: 18-3066

One lead sample (AP49-H-L-13) was found to be greater than 0.06% by weight and less than 0.5% by weight and is considered LCP (Table 3-2). The remaining 13 samples were less than the LCP and LBP thresholds, and are considered NLC. The laboratory analytical report is included in Appendix D.

MAIN FLOOR

BASEMENT

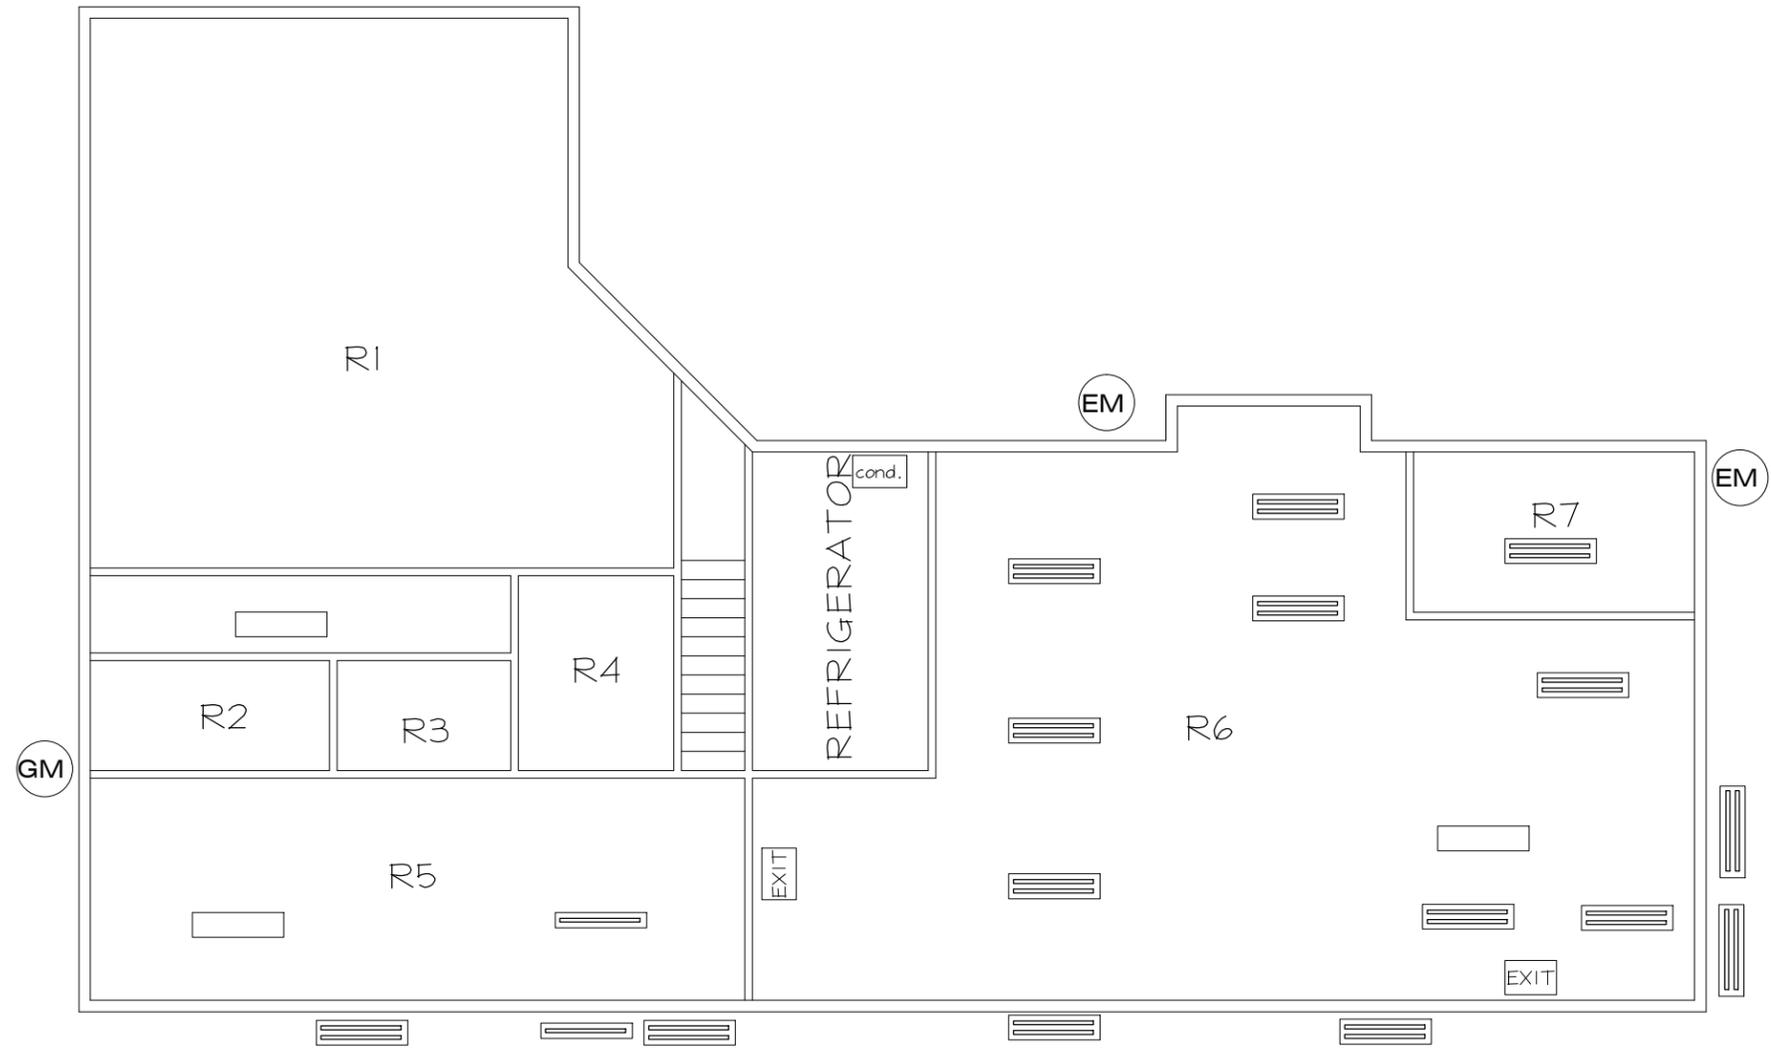
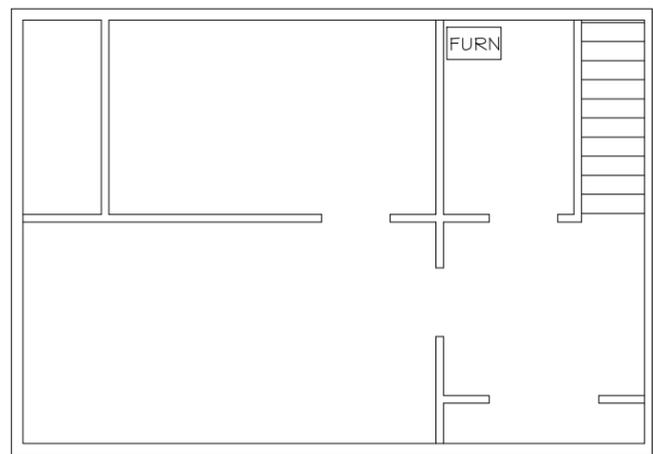
Several suspect RBMs were visually identified throughout the structure. RBMs that are a cause of concern, when discovered, are discussed in Section 4.3. A complete list of the RBMs is presented in Table 3-3, and selected locations of the RBMs are depicted in Figure 4.

MAIN FLOOR

BASEMENT

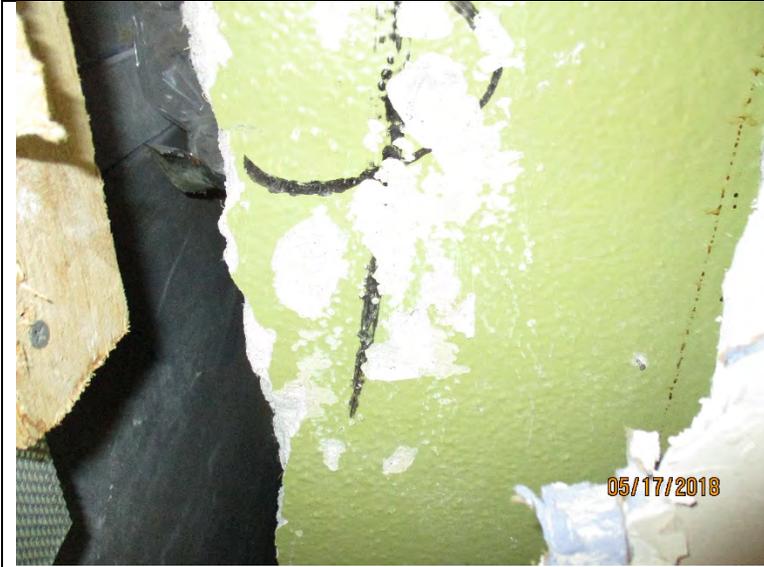
Sample Represented –
AP49-H-L-13

POSITIVE LEAD SAMPLE
MATERIAL PHOTOGRAPHS

LCP – Green

While the TCLP results indicate that the waste stream is not characteristically hazardous with respect to lead content, LCP and LBP are still present in the building materials. Therefore, the contractor responsible for demolition of this structure is notified with receipt of this report of the presence or potential presence of LCP and/or LBP in the building materials that comprise the building. The contractor should also notify their employees of the presence of LCP or LBP prior to any disturbance and make the US Department of Labor OSHA publication number 3142-12R 2004 available to their workers. (“Lead in Construction”, <http://www.osha.gov/Publications/osha3142.pdf>). The standards address topics such as PELs for workers, exposure assessment, protection of employees during assessment of exposure, employee notification, PPE, medical surveillance, along with other topics related to working with LCP and LBP.
